DSTO-TN-0063

Static and Fatigue Test  
Loading Development for an  
F-111 Bonded Composite  
Repair Substantiation

*K. Walker and G. Swanton*

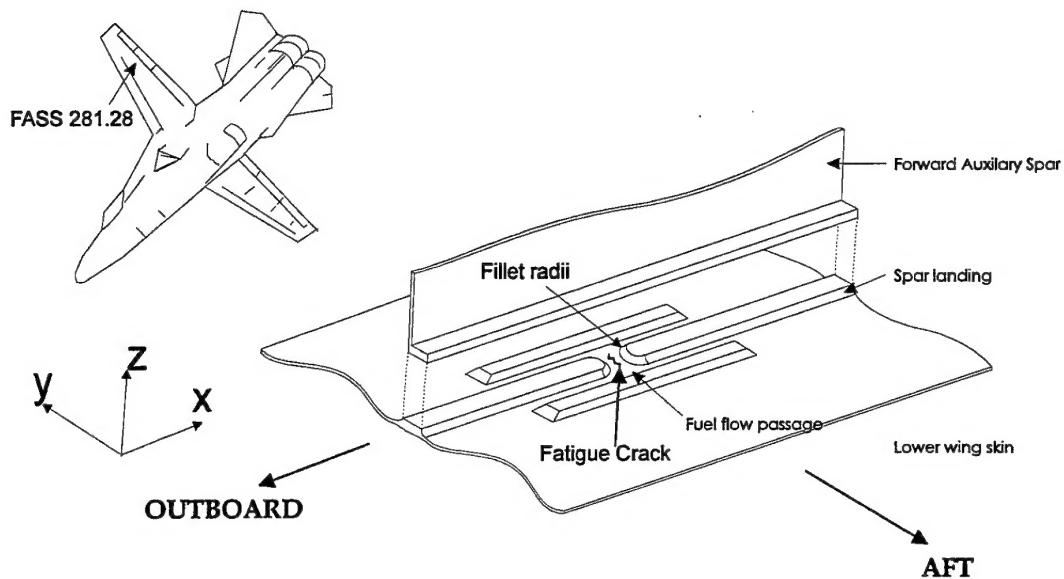
*Figure 1. Location of Cracking in F-111 Lower Wing Skin*

In February 1994, a 48 mm (tip to tip) through thickness chordwise fatigue crack was discovered at a Fuel Flow Passage (FFP) in the port lower wing skin of a Royal Australian Air Force (RAAF) F-111C aircraft (Tail Number A8-145). The crack was located in the outboard section of the wing, approximately mid way between the inboard and outboard fixed pylon at Forward Auxiliary Spar Station (FASS) 281. The wing skin is manufactured from 2024-T851 Aluminium Alloy. The crack location is shown in Figure 1. Fracture mechanics calculations indicated that the presence of this crack had degraded the residual strength to 150 MPa (21.7 ksi) which is considerably less than the predicted Design Limit Stress for the area of 240 MPa (34.6 ksi, Reference 1).

A mechanically fastened metallic doubler repair option was initially considered but was rejected for a range of reasons including undesirable aerodynamic implications and because the crack and the underlying structure would then be uninspectable. The only alternative to scrapping the wing was a bonded composite repair. A bonded boron epoxy repair was designed and implemented by RAAF personnel, on the basis of design principles and application procedures developed by Defence Science and Technology Organisation (DSTO, References 2 and 3) and now incorporated by the RAAF in an Engineering Standard (Reference 4). Details of the repair design are given in Reference 5. The repair was granted interim approval, pending the results of a
